Nutrient Reduction PIC: Murden Cove/Fletcher Bay
National Estuary
Program (NEP): Toxics and Nutrients Prevention, Reduction and Control
Grant #G1300087
1/1/2013 – 12/31/2015

Susan Walther

Environmental Health Specialist

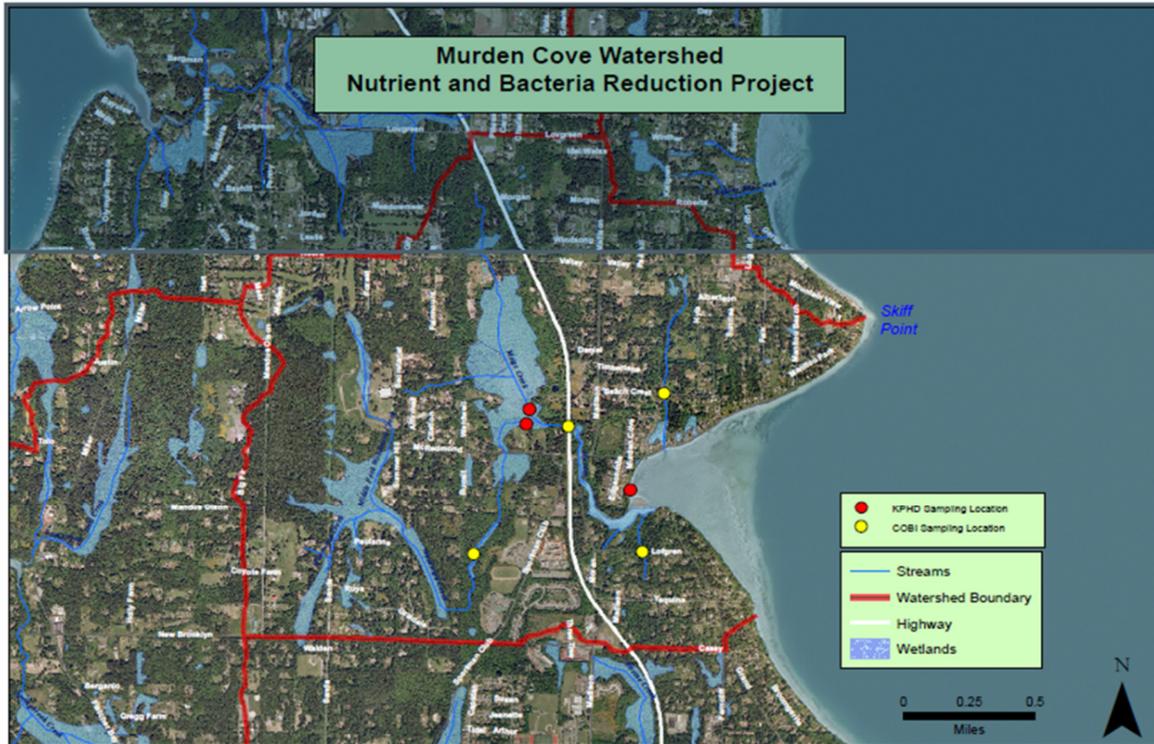
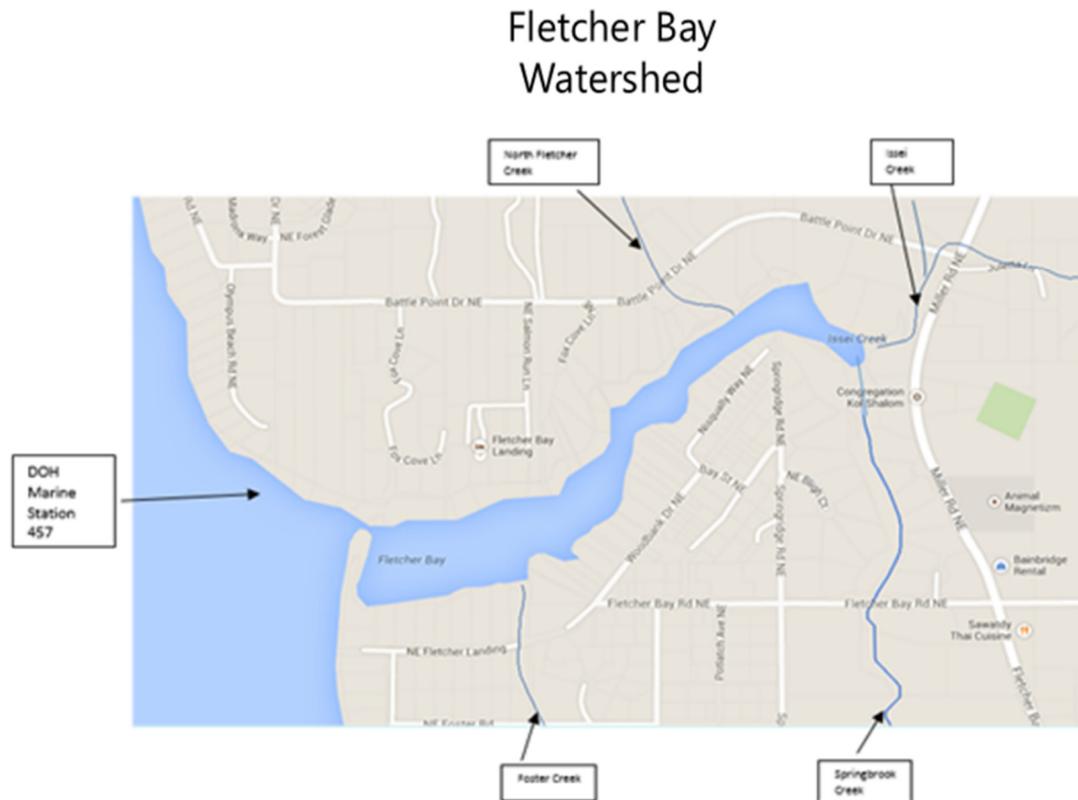
Figure 1. Project Areas

Kitsap Public Health successfully completed the project by meeting the goals and objectives set forth in the grant contract and work plan. Surveys were conducted in both the Murden and Fletcher Bay watersheds as shown in Figure 1.

There were 32 monthly monitoring events along Murden Creek and its' tributary, Meigs Creek, which included three storm events during this project. Two of these storm events were conducted during wet-weather months (between October-April), and one was completed in a dry-weather month (May-Sept). MUR1 (nearshore station), MUR2 (mainstem Murden Creek) and MUR3 (Murden tributary, Meigs Creek) are indicated as KPHD sampling locations on the Murden Cove map in Figure 1. In addition, the City of Bainbridge Island and its' volunteers sampled three other locations and added a fourth in May of 2014 during the monthly monitoring events, also indicated on the map in Figure 1. All creek monitoring was completed during the 2013-2015 timeline identified in the work plan.

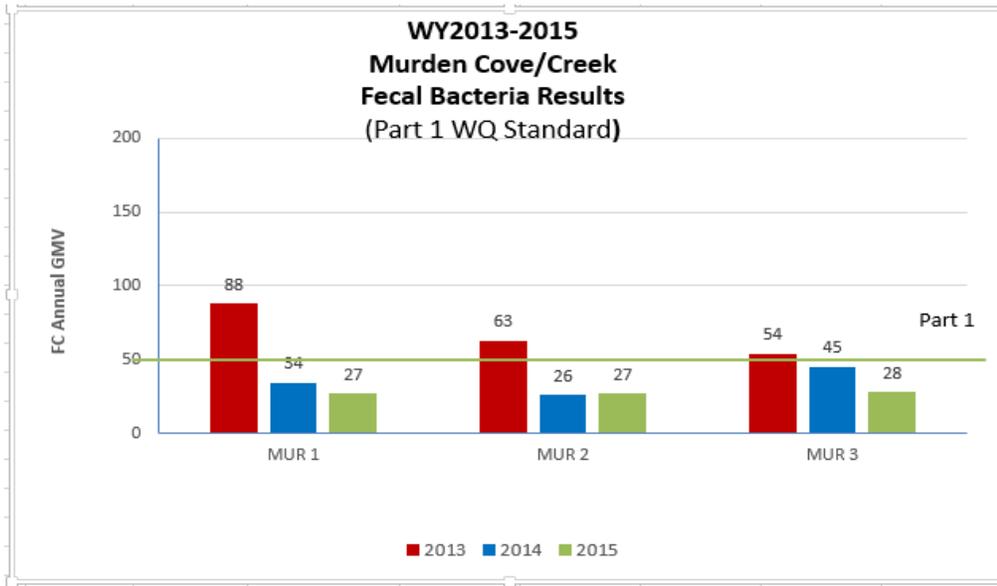
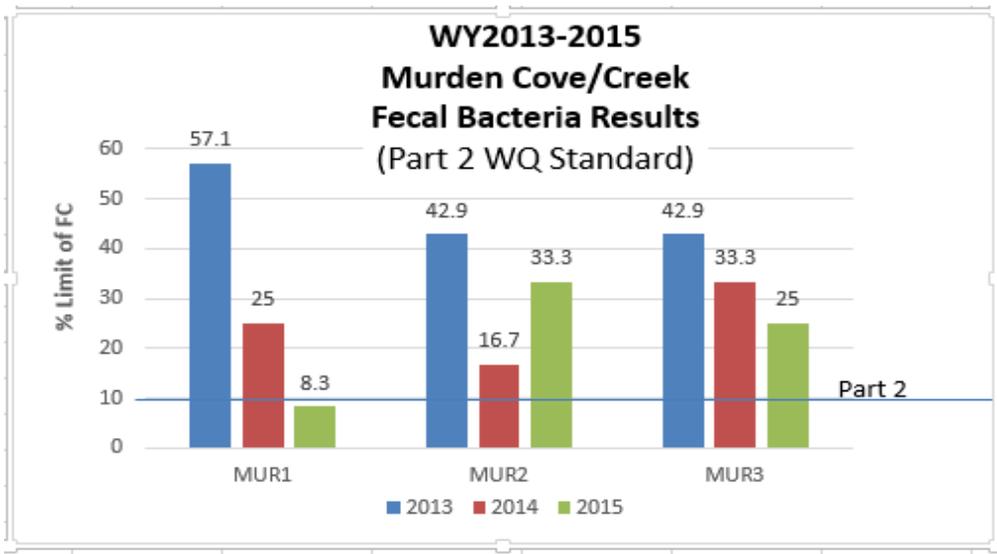
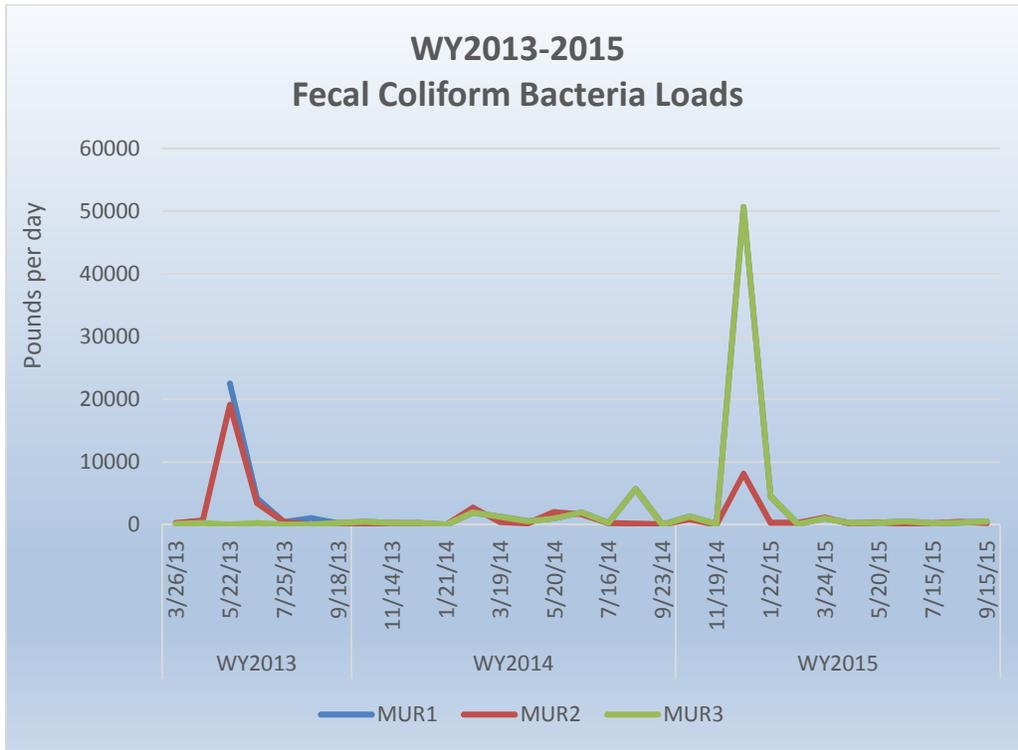
Figure 2. Fecal Bacteria Results and Water Quality Standards

Monthly monitoring data included; fecal bacteria (FC), nutrients and physio-chemistry parameters. Fecal bacteria data, as shown in Figure 2, for Water Years 2013-2015 indicates that all three stations had improving trends. In Water Year 2013 all three stations failed to meet Part 1 (geometric mean less than or equal to 50 FC/100 ml) and Part 2 (not more than 10% of all samples obtained for calculating a geometric mean greater than 100FC/100ml) of the Water Quality Standards. These standards are shown in Figure 2 as the freshwater standard for extraordinary primary contact. In Water Years 2014, all stations met Part 1 and failed Part 2 and

in Water Year 2015 all stations met Part 1 and MUR1 showed continued improvement by meeting Part 2 Standards as well.

In addition, Figure 2 Fecal Bacteria Loads show that MUR3, the tributary to Murden Creek had a few peaks in bacterial load which may be attributable to the beaver dam located above the sampling location.

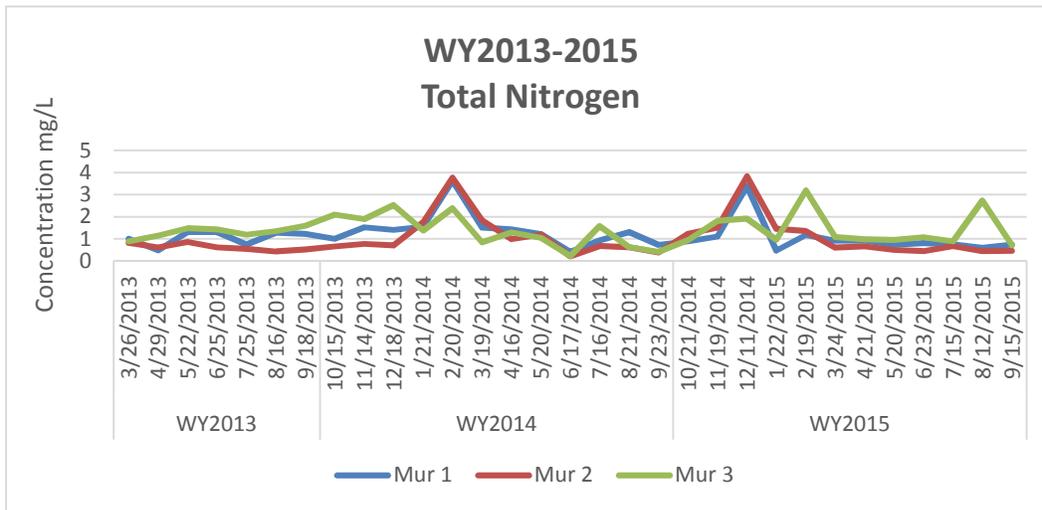
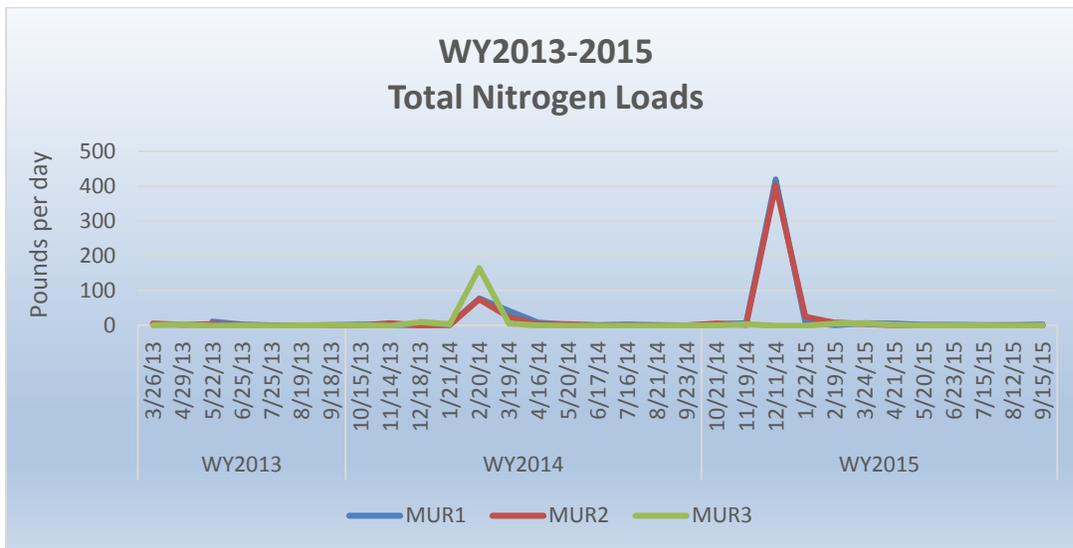
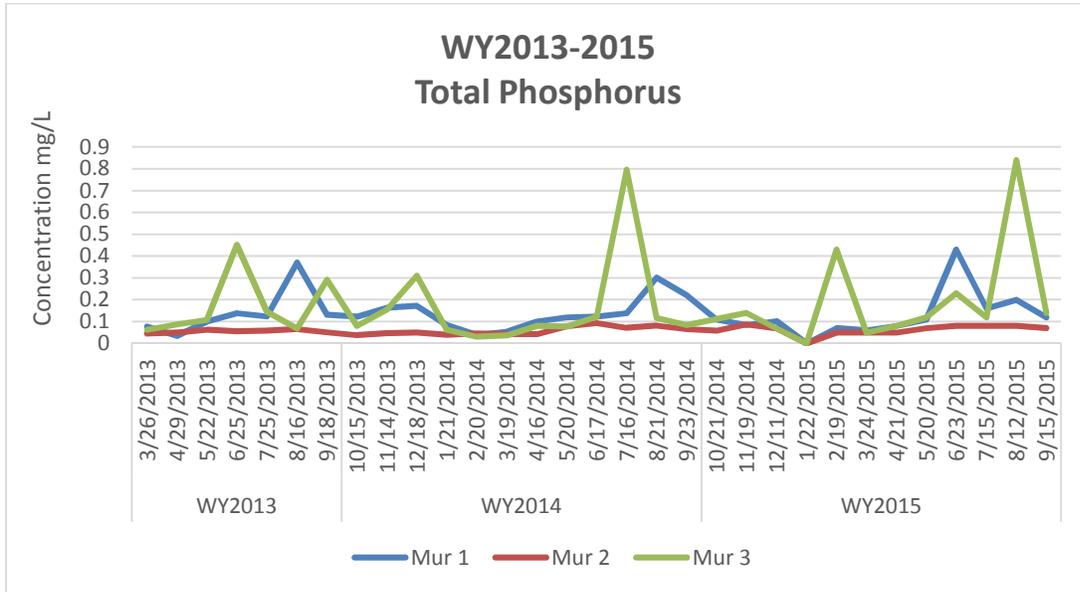
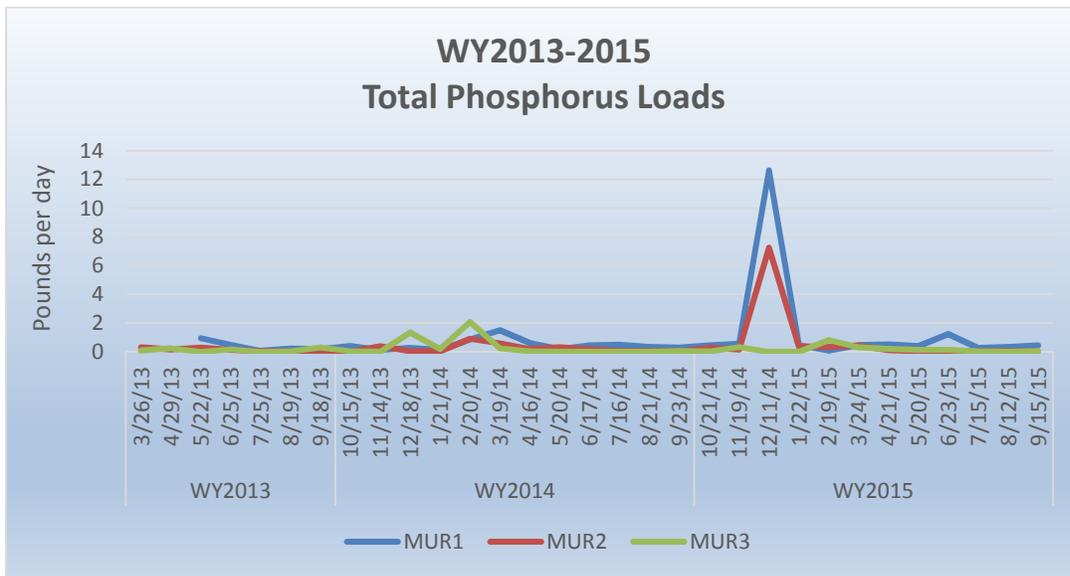
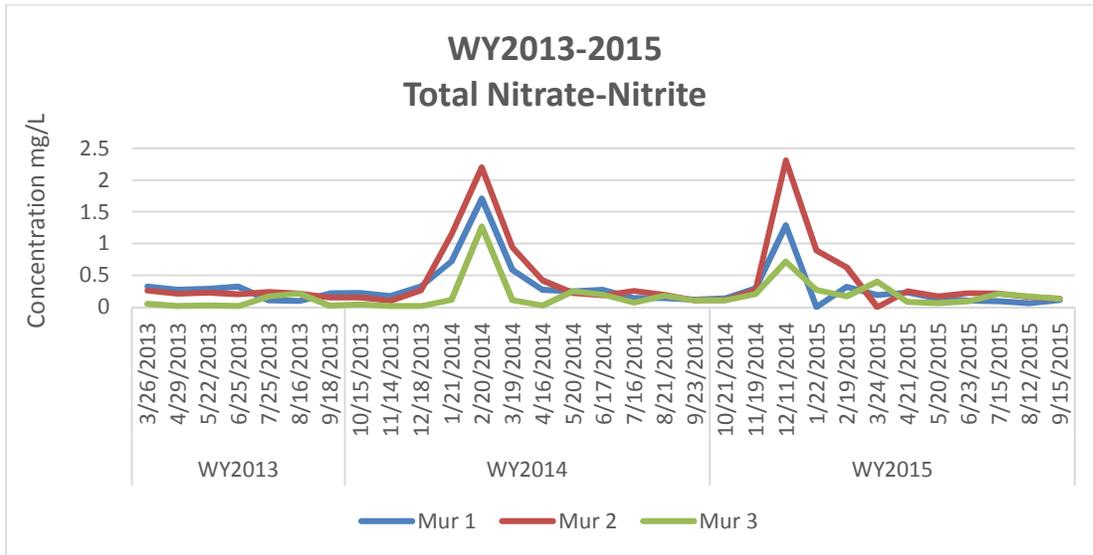
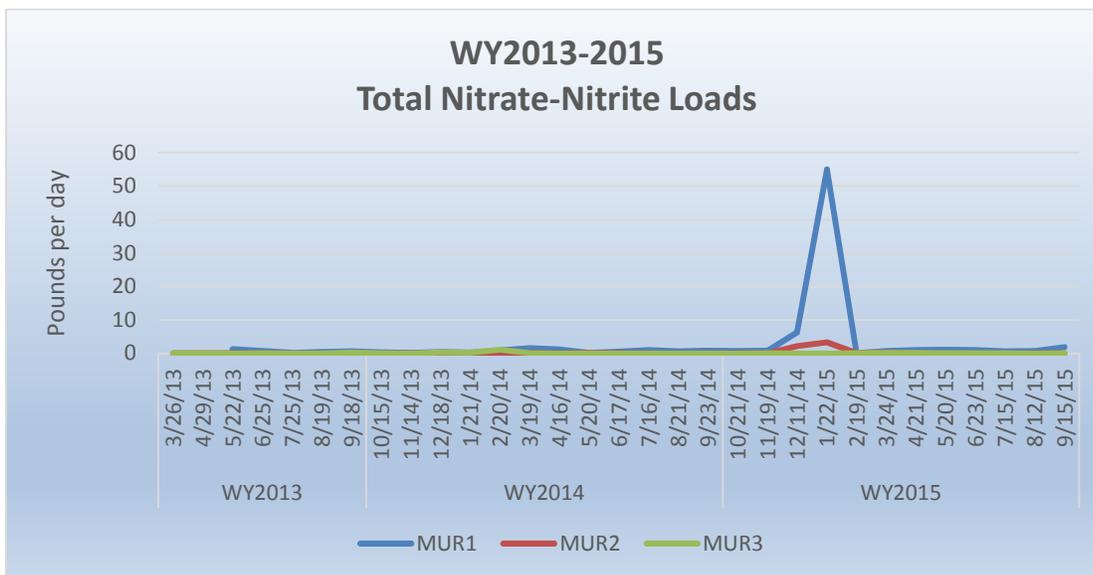
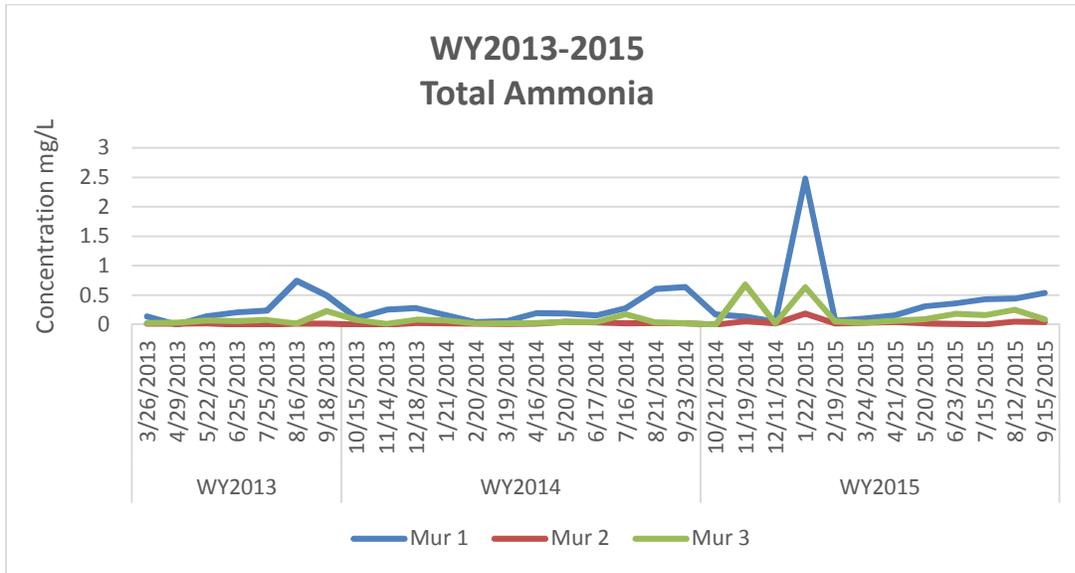
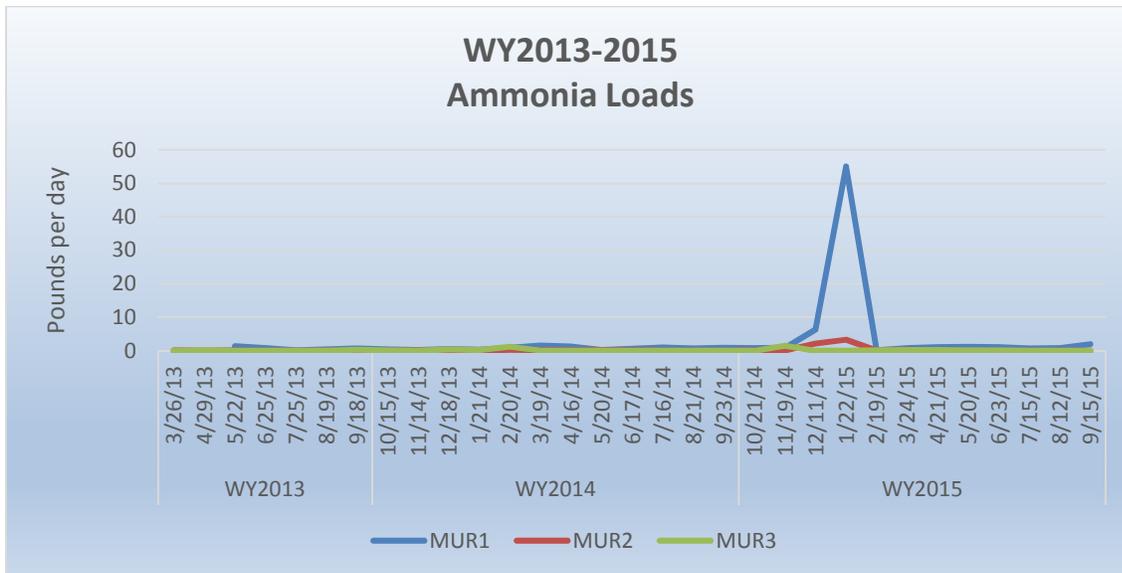
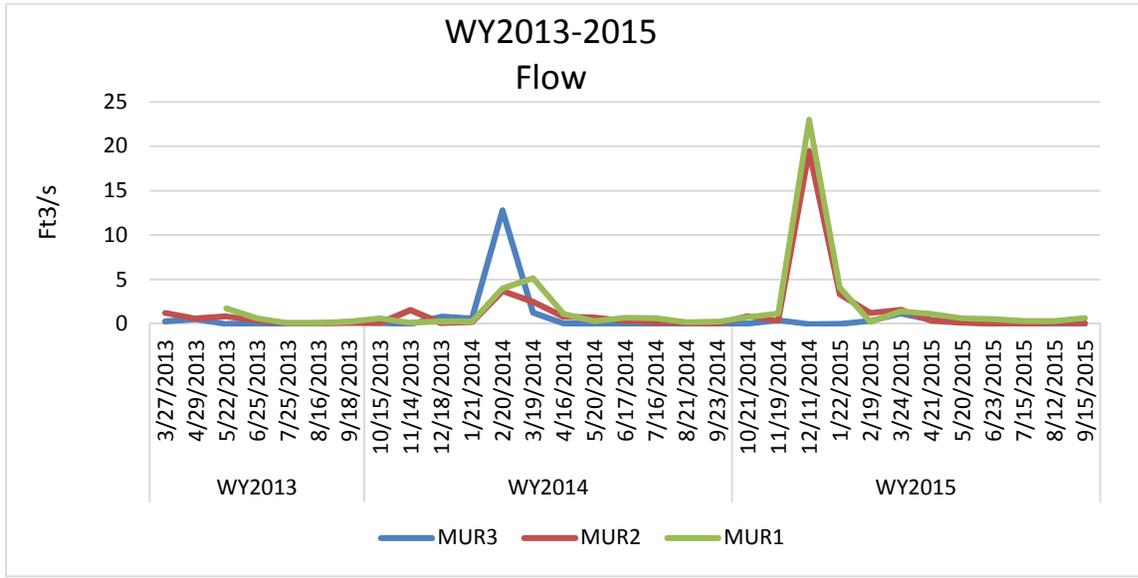
Figure 3. Nutrient Levels, Loads and Flow Measurements

In Figure 3, all nutrient levels and load calculations are shown for total nitrogen, total phosphorus, total nitrate-nitrite and total ammonia for each water year from 2013-2015. Data shows that there are some seasonal variations in nutrient levels and loading. Typically during higher flows, as seen in Figure 3, total nitrogen and total nitrate-nitrite levels increase and total phosphorus levels decrease. Noticeable peaks occurred on 2/20/2014 and 12/11/2014, rain events of 0.22 and 2.15 inches respectively in the previous 24 hours. As the charts show, total nitrogen is higher during the winter season and total phosphorous is higher during the summer. The total nitrogen levels during the winter follow the observed pattern of elevated levels of nitrogen from surface waters, as established in the USGS (Paulson et al. 2006) report findings. These findings also delineated the sources of the nitrogen from atmospheric input, shallow subsurface flow, regional ground water and surface water. Our study did not speciate nutrients and therefore we do not know the source of the nitrogen.

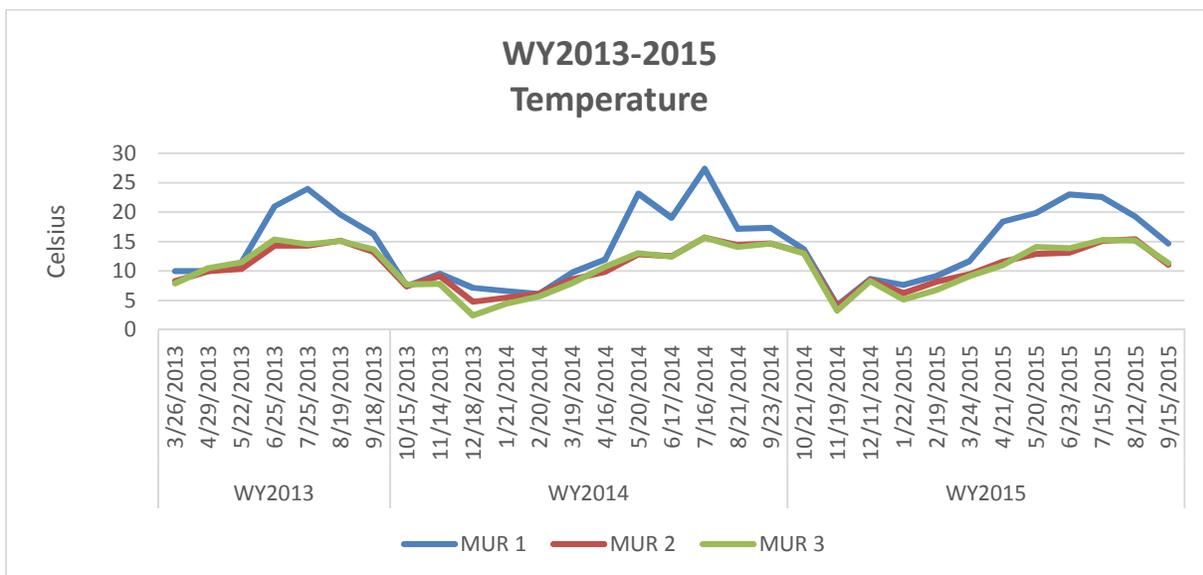
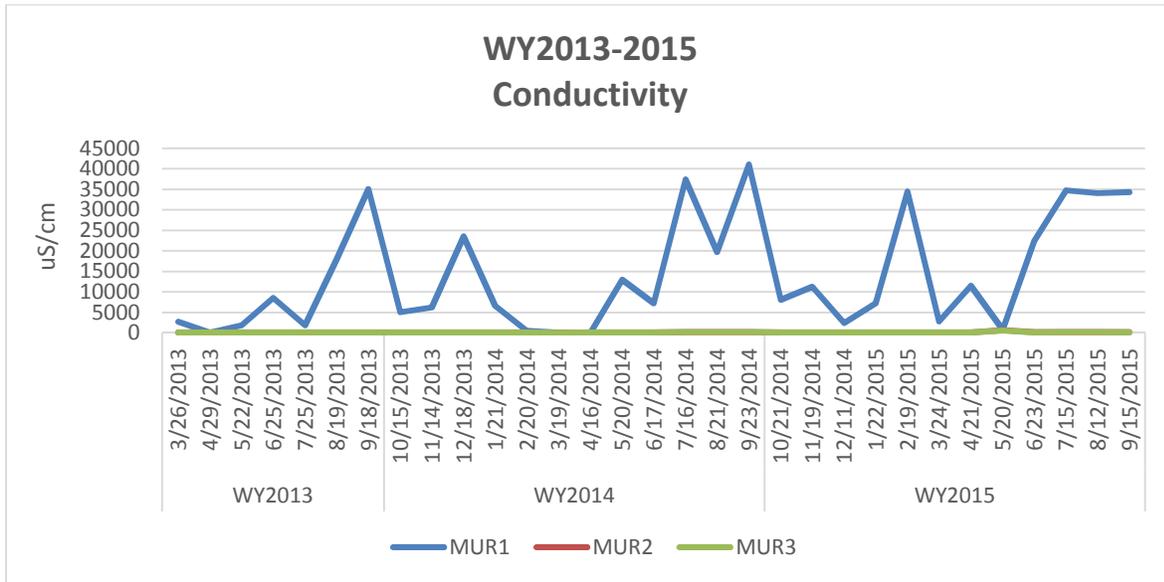
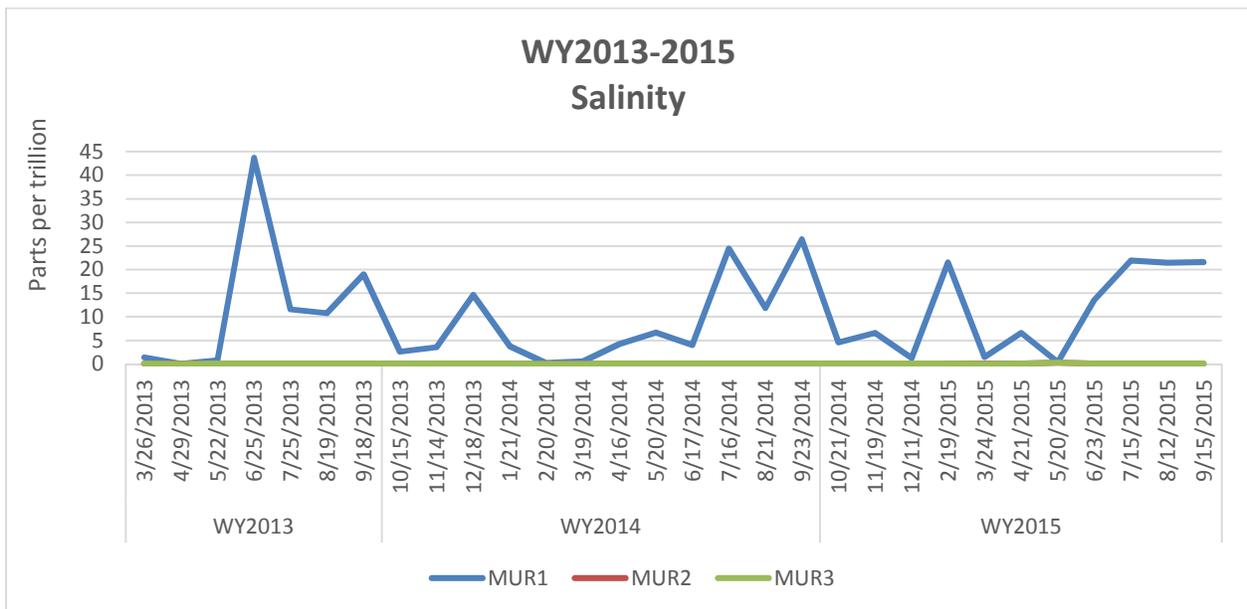
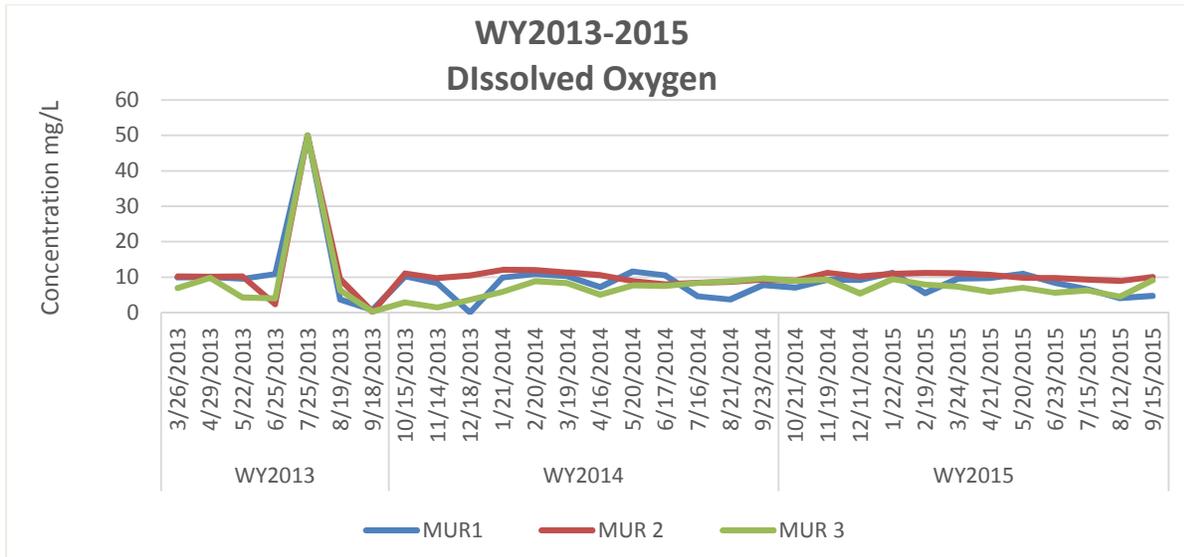
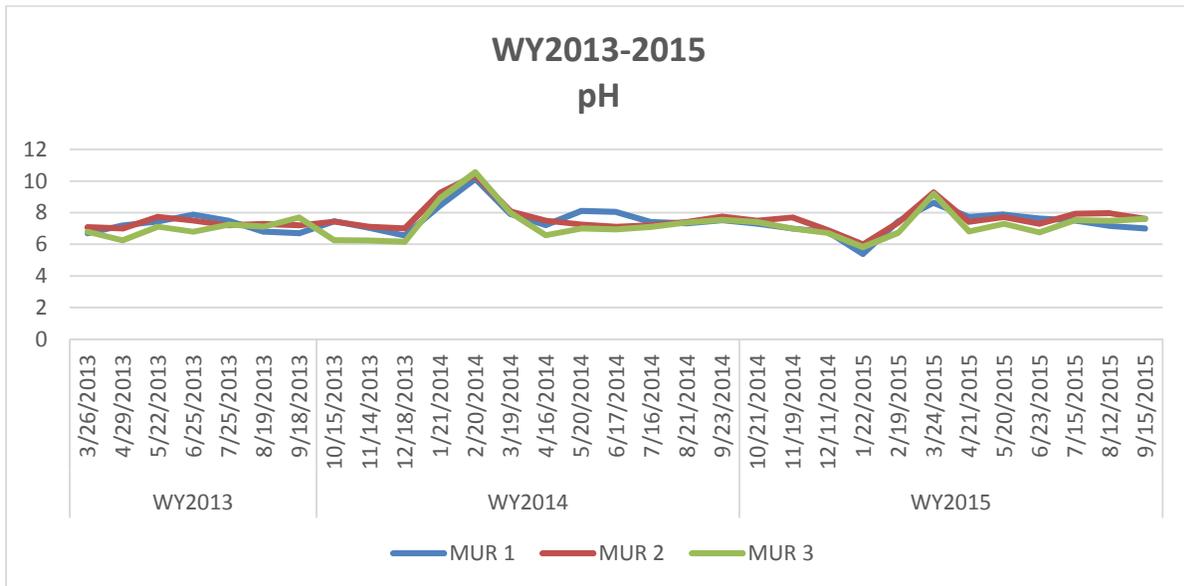
Figure 4. Physical Parameters Results

Measurements for physical parameters of temperature, conductivity, salinity, dissolved oxygen and pH were taken during the 32 monthly sampling events. As can be seen by the results in Figure 4 below, temperatures rose at all stations during the dry weather and were fairly uniform, except for slightly warmer temperatures at MUR1, the nearshore station. Typically, when temperatures are higher, dissolved oxygen is lower, however a definitive correlation is not apparent during our sampling events. It does appear as though MUR3, Meig’s Creek, is impacting the dissolved oxygen levels, since a beaver dam is above the sampling location. This results in an area of stagnant water that flows through and over the beaver dam into the sampling area and may be a contributing factor.
